Memorandum

To: Half Moon Lake Protection & Rehabilitation District Board
From: Meg Rattei, Barr
Subject: Assessment of Half Moon Lake Wild Rice and Response of the Wild Rice to an Application of the Herbicide ProcellaCOR in 2022
Date: February 23, 2024
Project: Half Moon Lake Eurasian Watermilfoil Management
c: Keegan Lund and Dr. Mark Heilman, SePro

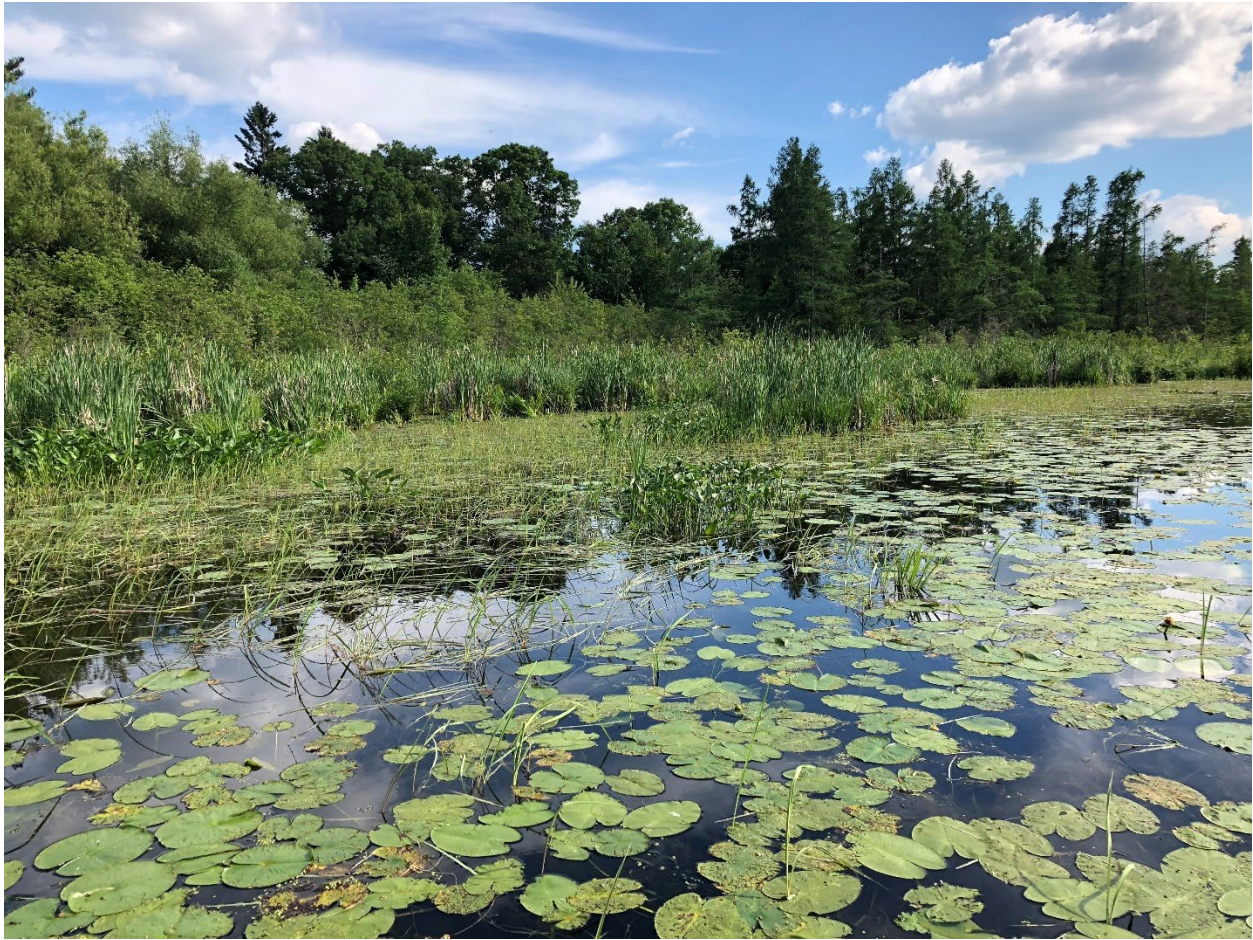
Figure 1 Wild Rice (*Zizania palustris*) in Half Moon Lake on June 22, 2018

Wild rice was first observed in Half Moon Lake during a whole lake point intercept plant survey completed by the District during June 21 through 23, 2018 (Figure 1). The vast majority of the wild rice plants were located near the creek entrance along the north shoreline near the boat landing on the north end of the lake (Figure 2). Wild rice plants were collected on the sample rake at two sample locations and visually observed at a third sample location. The plant surveyor noted the highest density of wild rice plants was a 2 on a scale of 1 to 3 with most plants having a density of 1 on a scale of 1 to 3 (Figure 3). None of the plants appeared to be dense enough for a profitable human harvest.

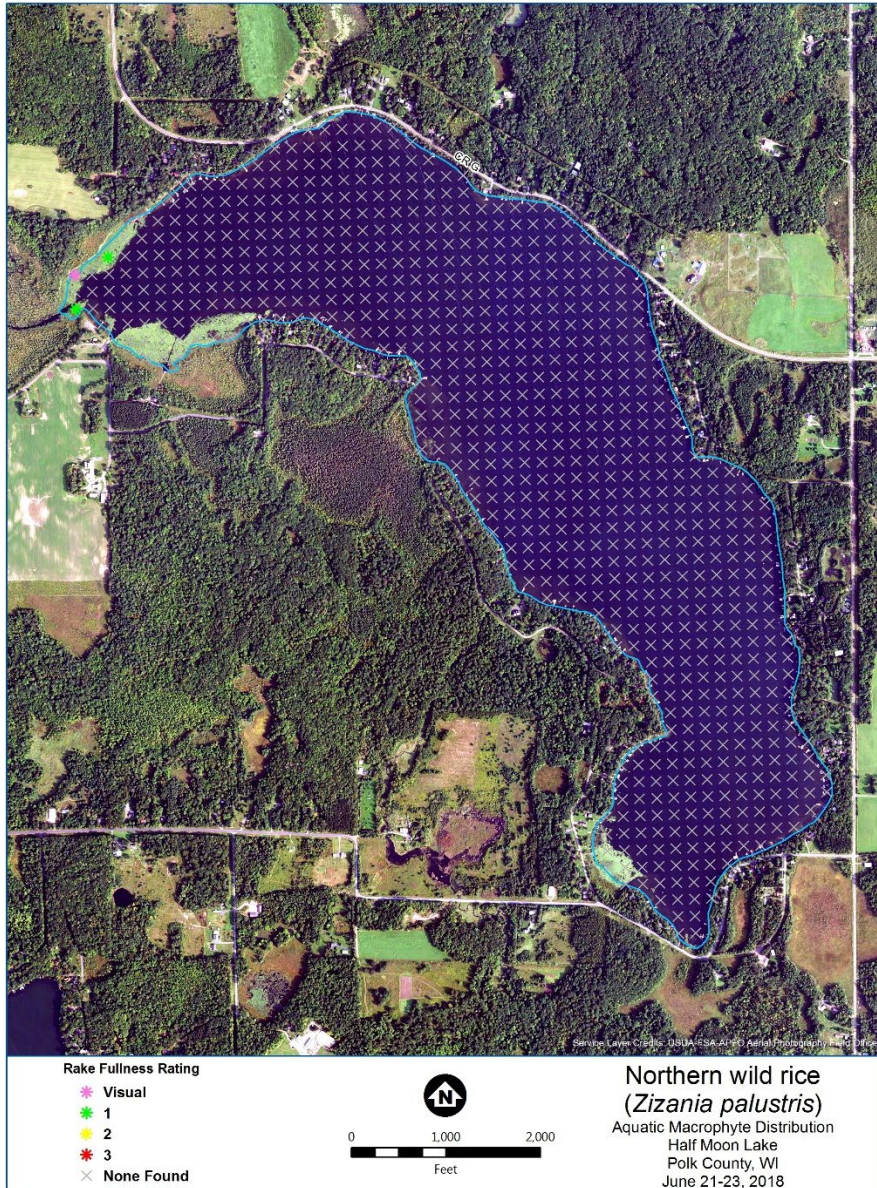
Figure 2 Location of Wild Rice in Half Moon Lake June 22, 2018

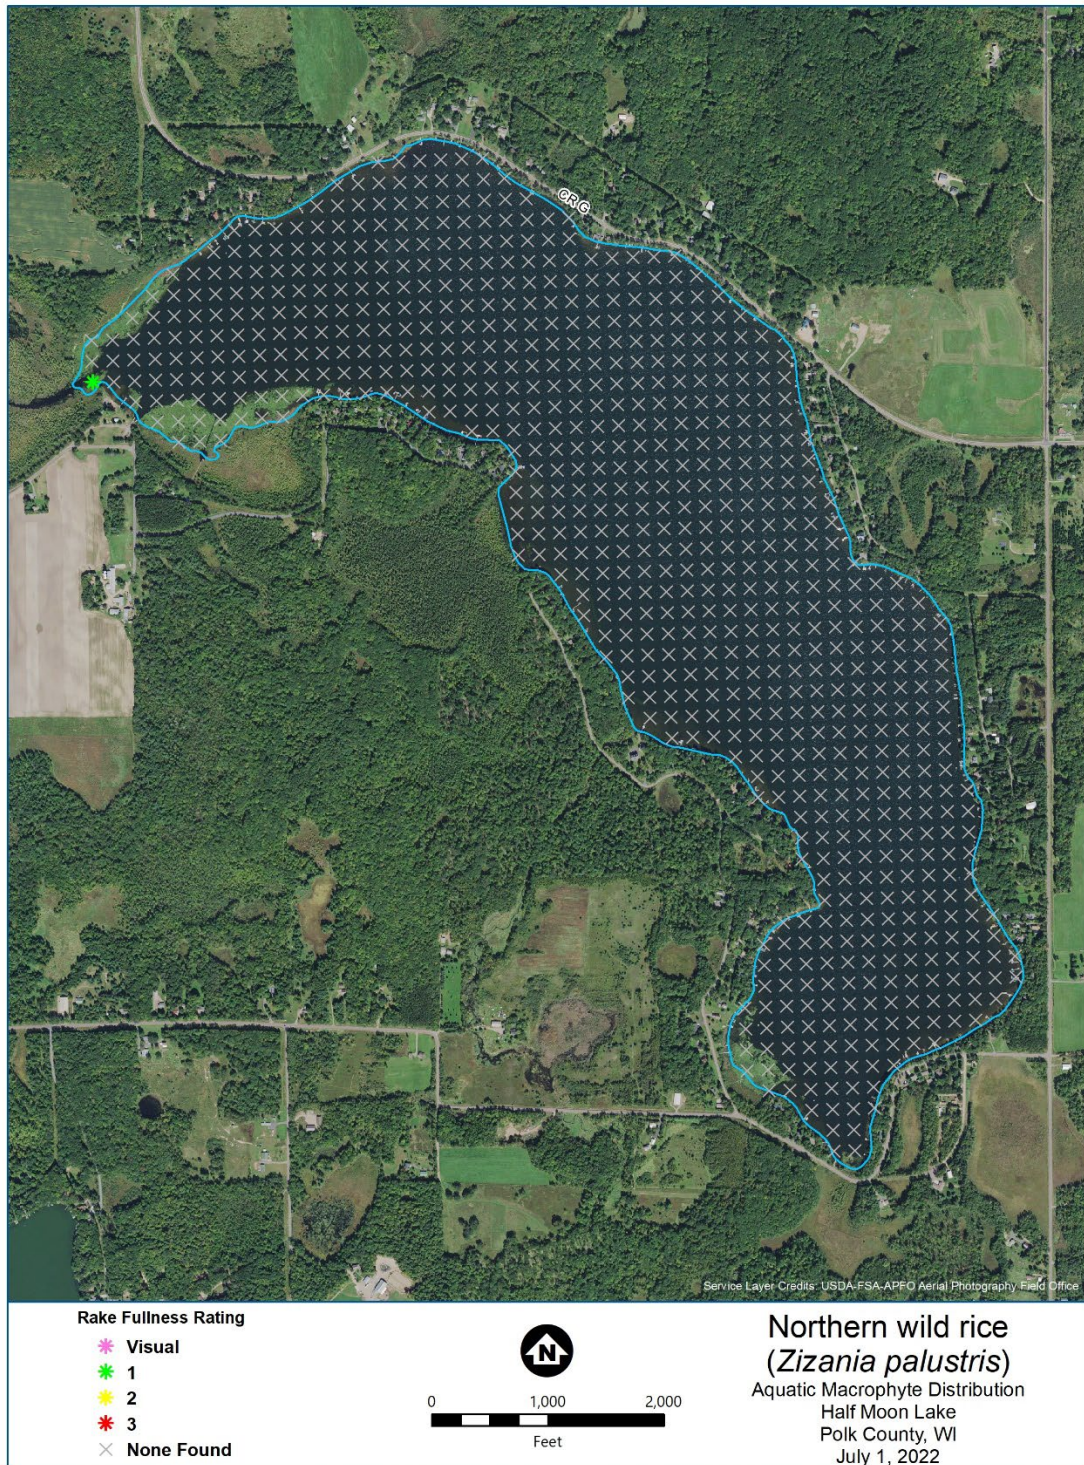
Figure 4 Location of Wild Rice in Half Moon Lake July 1, 2022

Wild rice was again observed in Half Moon Lake during a whole lake aquatic plant survey completed by the District on July 1, 2022. All wild rice plants were located near the creek entrance along the north shoreline near the boat landing on the north end of the lake (Figure 4). Wild rice plants were collected on the sample rake at one location and this location coincided with one of the locations in which wild rice plants were collected on the sample rake in 2018. The maximum rake density of plants collected in 2022 was 1 on a scale of 1 to 3 (Figure 3). The surveyor didn't see more than 100 to 200 plants in the lake. All plants were goose cropped and it was questionable whether or not the plants would set grain. Consequently, there were no areas on the lake that were suitable for human harvest.

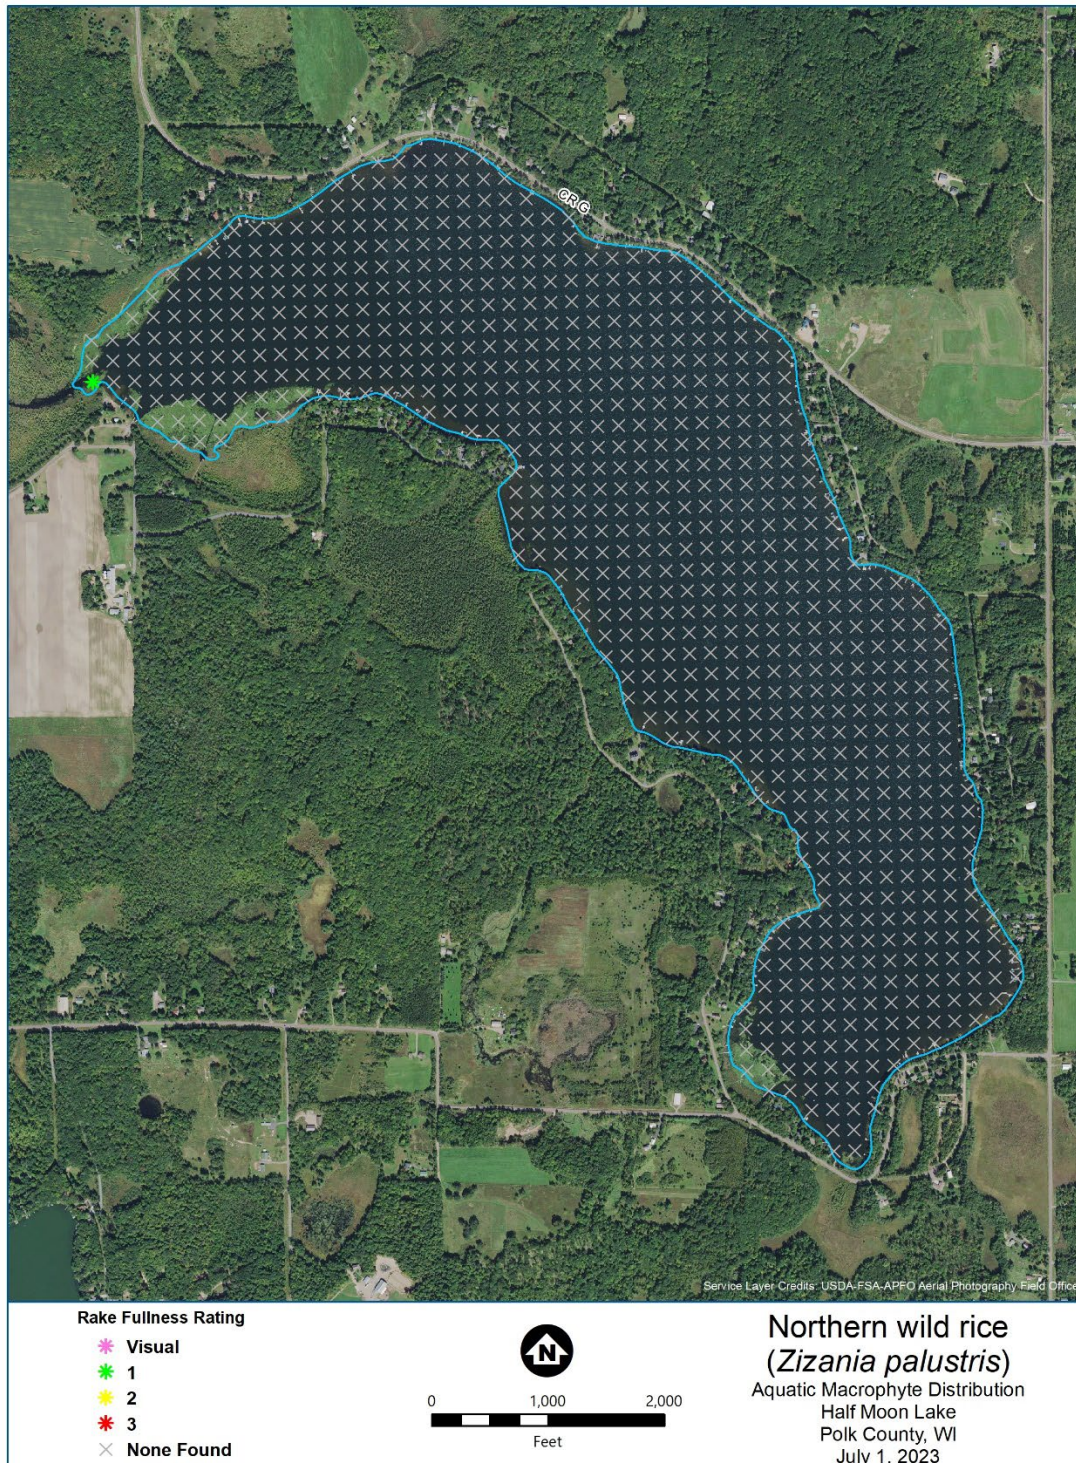
Figure 5 Location of Wild Rice in Half Moon Lake July 1, 2023

Wild rice was again observed in Half Moon Lake during a whole lake aquatic plant survey completed by the District on July 1, 2023. All wild rice plants were located near the creek entrance along the north shoreline near the boat landing on the north end of the lake. Wild rice plants were collected on the sample rake at one location and this location coincided with the same location in which wild rice plants were collected on the rake in 2022 (Figure 5). The surveyor delineated the boundary of the wild rice plants in the lake and created a map showing the area in which wild rice plants were found (Figure 6). The surveyor estimated there were no more than a few hundred wild rice plants and all plants were goose cropped (Figure 7). The surveyor indicated most wild rice plants seemed unlikely to set grain and no areas were suitable for human harvesting.

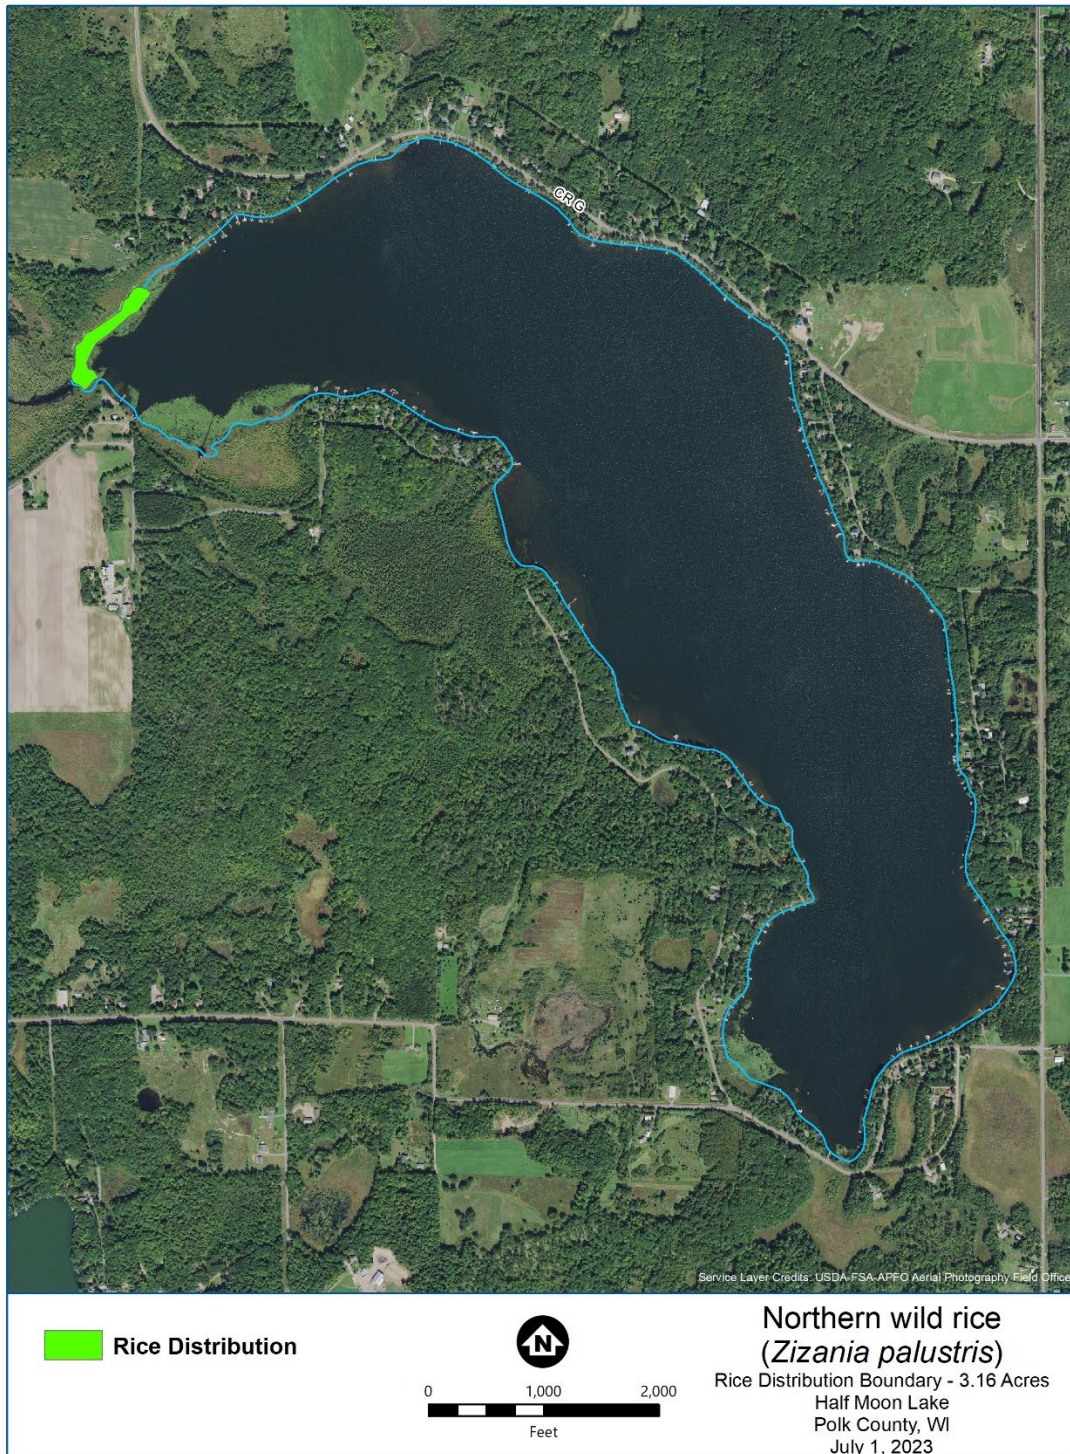
Figure 6 Boundary of Wild Rice Area from Survey Completed on July 1, 2023

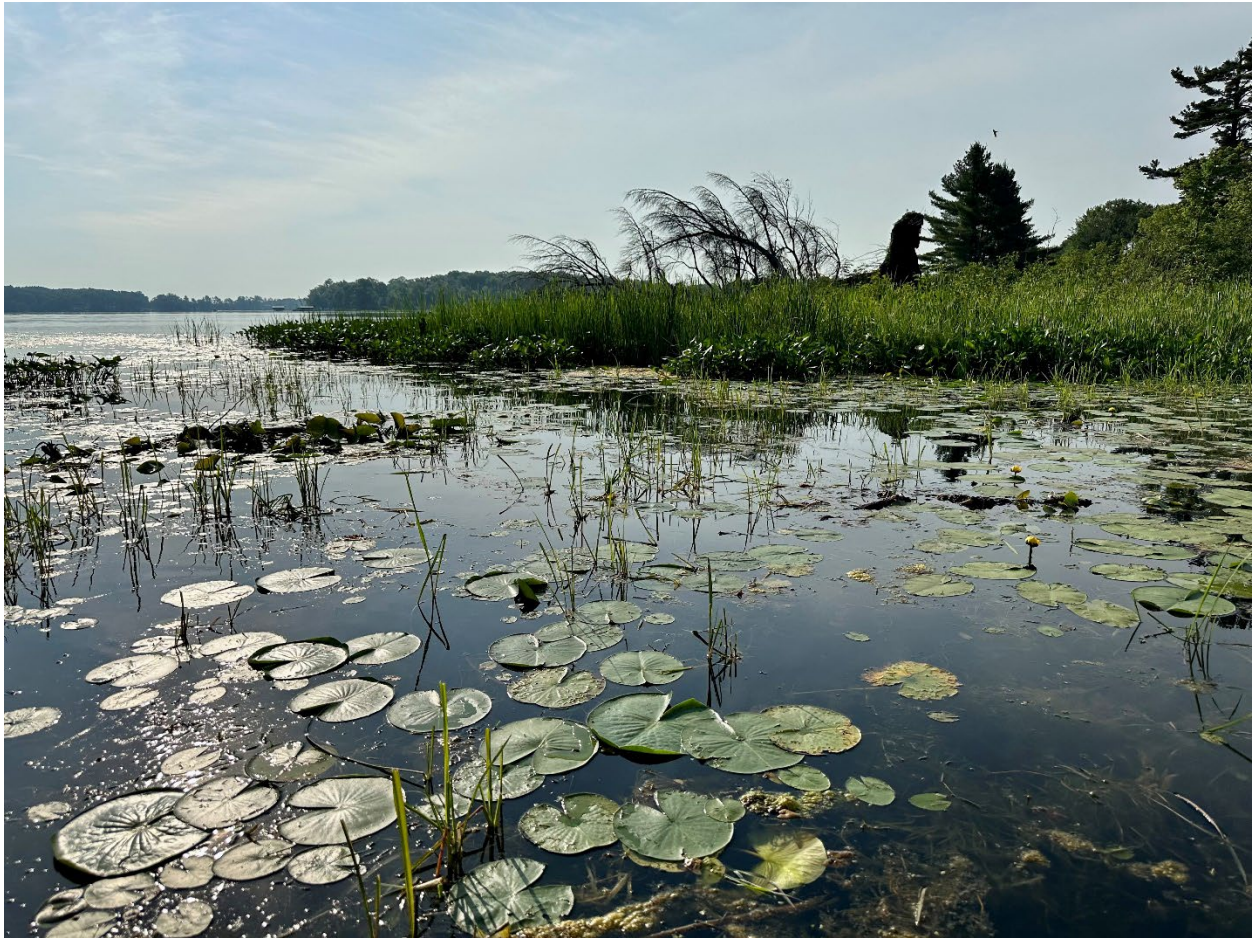
Figure 7 Wild Rice (*Zizania palustris*) in Half Moon Lake on July 1, 2023

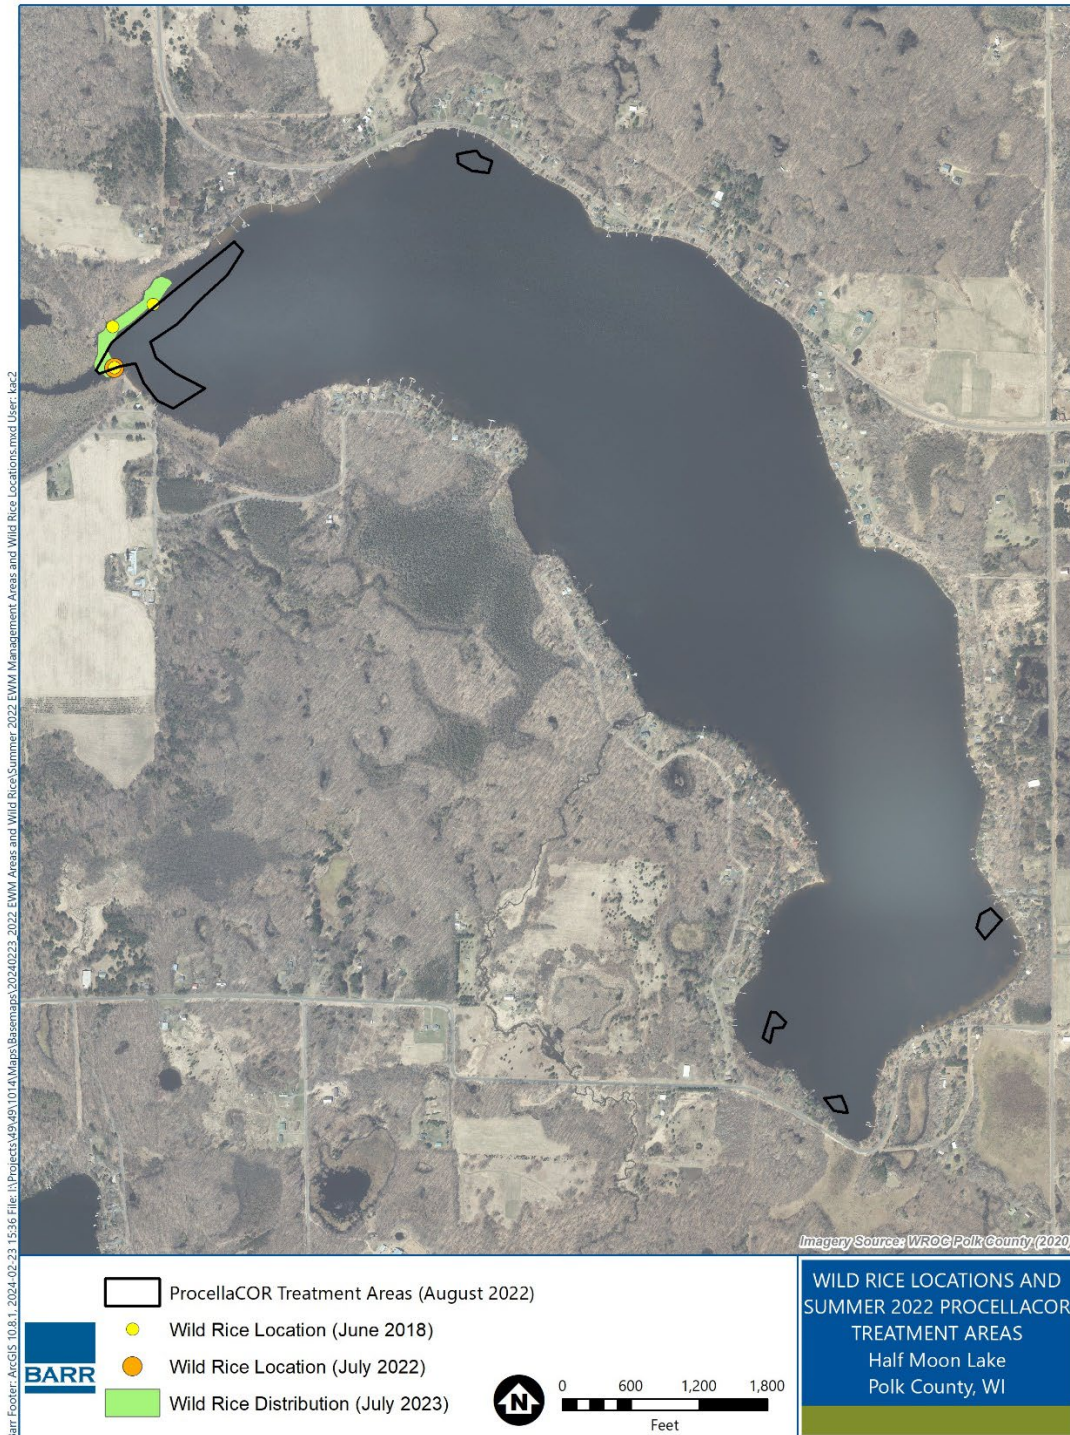
Figure 8 2018, 2022, and 2023 Wild Rice Locations and August 1, 2022 ProcellaCOR Treatment Areas

Eurasian watermilfoil (EWM) was first observed in Half Moon Lake during October 2021. On July 28, 2022 the Half Moon Lake Protection and Rehabilitation District received a WDNR a permit for the removal of 13.71 acres of EWM using ProcellaCOR herbicide. Treatment occurred on August 1. The vast majority (11.09 acres) of the ProcellaCOR treatment area was at or near the area where wild rice had been observed in the lake (Figure 8).

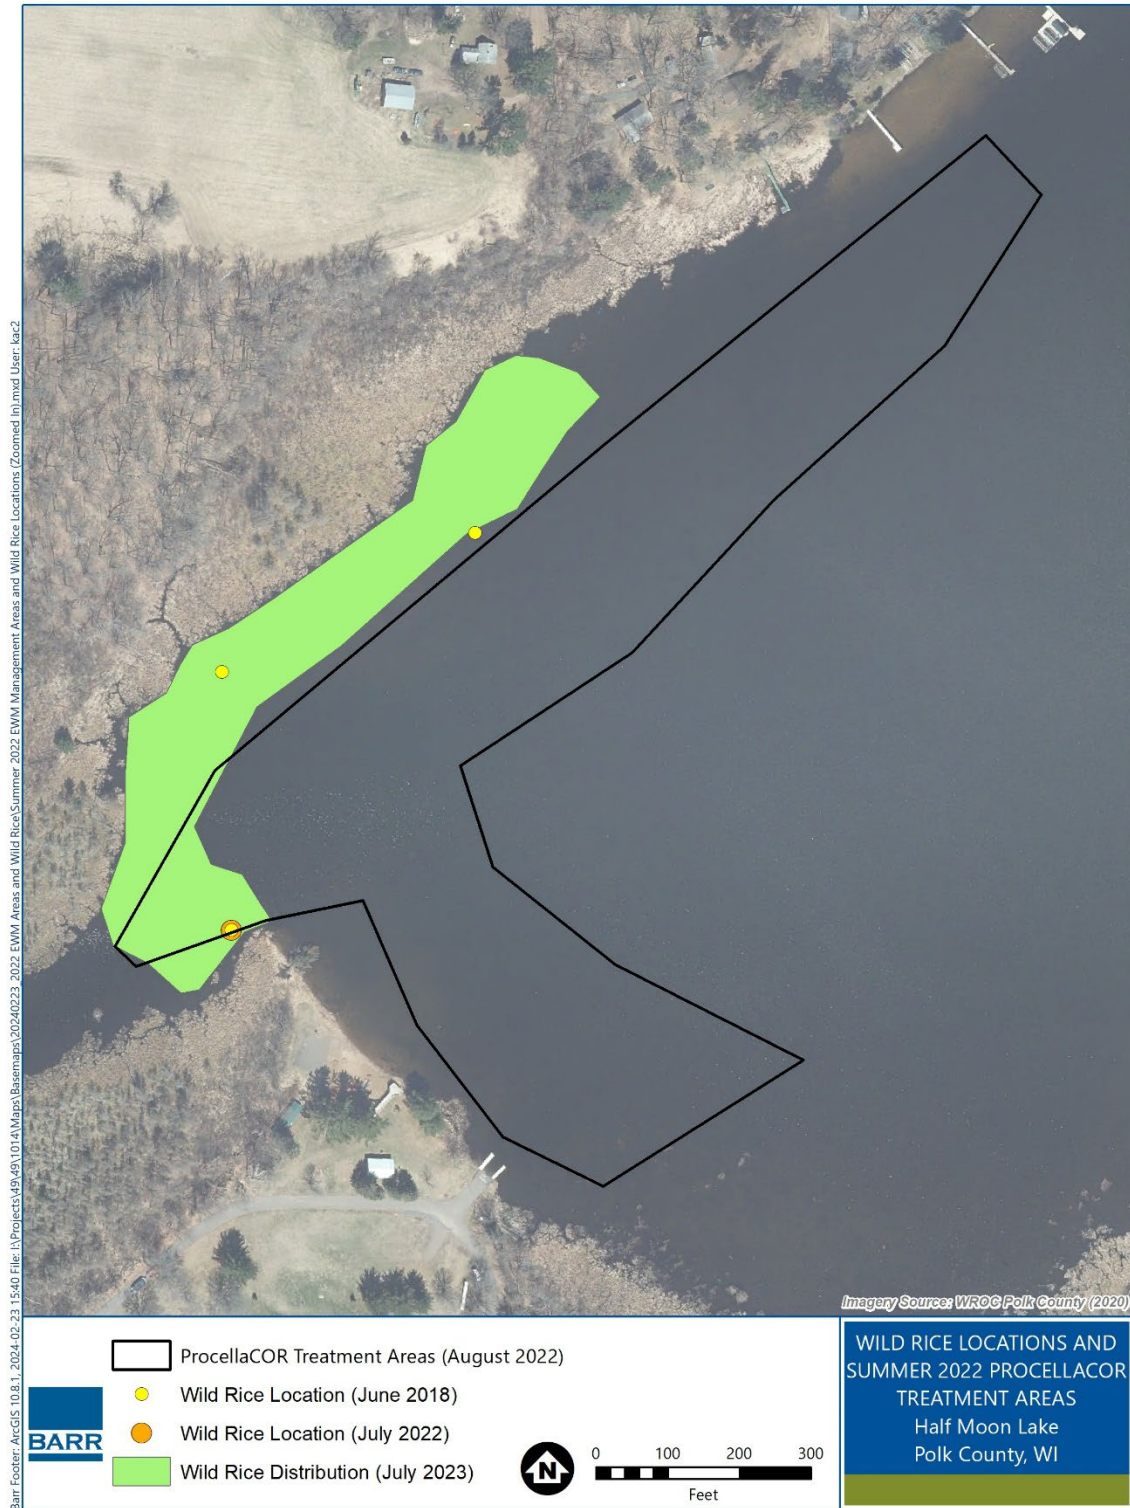
Figure 9 2018, 2022, and 2023 Wild Rice Locations Compared with the August 1, 2022 ProcellaCOR Treatment Area Near the Boat Landing

The 2023 plant survey occurred after the 2022 ProcellaCOR treatment and, hence, provides post-treatment data to assess the response of the wild rice to the 2022 ProcellaCOR treatment. As shown in Figure 9, the area in which wild rice was observed in 2023 coincided with the area in which wild rice had been observed in both 2018 and 2022. The data suggest ProcellaCOR did not adversely impact the wild rice in Half Moon Lake.
