Half Moon Lake

2023 Eurasian Watermilfoil Management Results

Prepared for
Half Moon Lake Protection & Rehabilitation District

December 2023

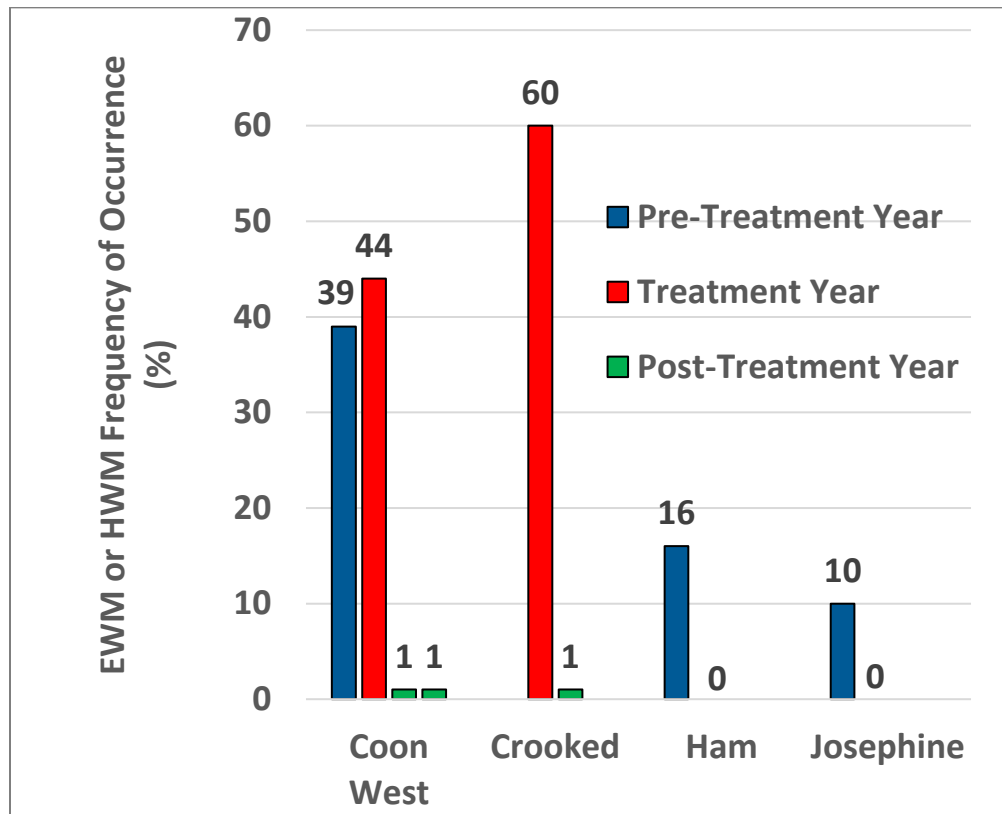
Figure 20 EWM or HWM Frequency of Occurrence during Pre-Treatment, Treatment, and/or Post-Treatment Years: Coon West Lake, Crooked Lake, Ham Lake, and Lake Josephine

Monitoring results from fluridone treatments of lakes with EWM and hybrid milfoil have documented the effectiveness of fluridone to control both (Figure 20) (Freshwater Scientific Services 2017a, Freshwater Scientific Services 2017b, MNDNR 2021a, MNDNR 2021b, and MNDNR 2021c).
