Eurasian Water-milfoil (*Myriophyllum spicatum*)
Fall Bed-mapping Survey
Half Moon Lake - WBIC: 2621100
Polk County, Wisconsin

Survey Conducted by and Report Prepared by:

Endangered Resource Services, LLC
Matthew S. Berg, Research Biologist
St. Croix Falls, Wisconsin
October 30, 2021

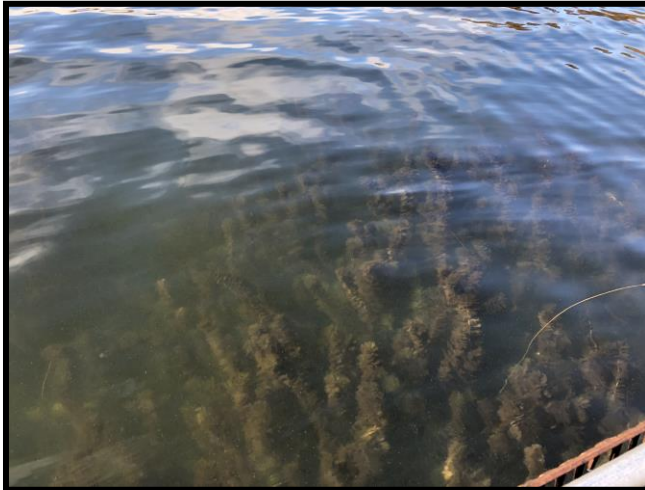
Large EWM bed near the boat landing 10/30/21

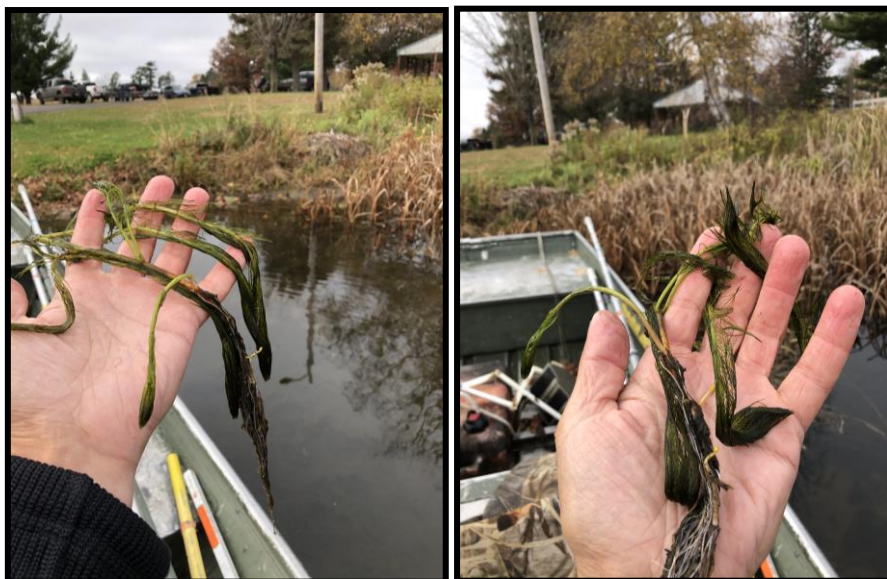
Figure 6: Rooted EWM Sprouts at the Landing 10/30/21

Even before launching our boat, we found evidence of Eurasian water-milfoil at the northwest public boat landing where several floating fragments had washed up on shore, and a couple of 6-inch sprouts were rooted in a foot of water (Figure 6). Further searching in this area located over 30 pioneer plants scattered among the Northern water-milfoil (*Myriophyllum sibiricum*) (NWM), native pondweeds (*Potamogeton* spp.), and lily pads of Spatterdock (*Nuphar variegata*) and White water lily (*Nymphaea odorata*). Immediately north of the landing, a small but moderately dense bed was canopied in up to 8ft of water (Figure 7). After finding another handful of plants in the channel leading to the active beaver lodge in the lake's northwest corner, we located the main bed expanding along the north shoreline. These plants were almost all growing in a narrow band on the outer edge of the rooted littoral zone in 8-13ft of water. In from this, plants tended to be more scattered; especially as the bottom substrate transitions from muck to sand and gravel. Further down the shoreline, we found only a few scattered individuals before plants disappeared entirely (Figure 8) (Appendix I).

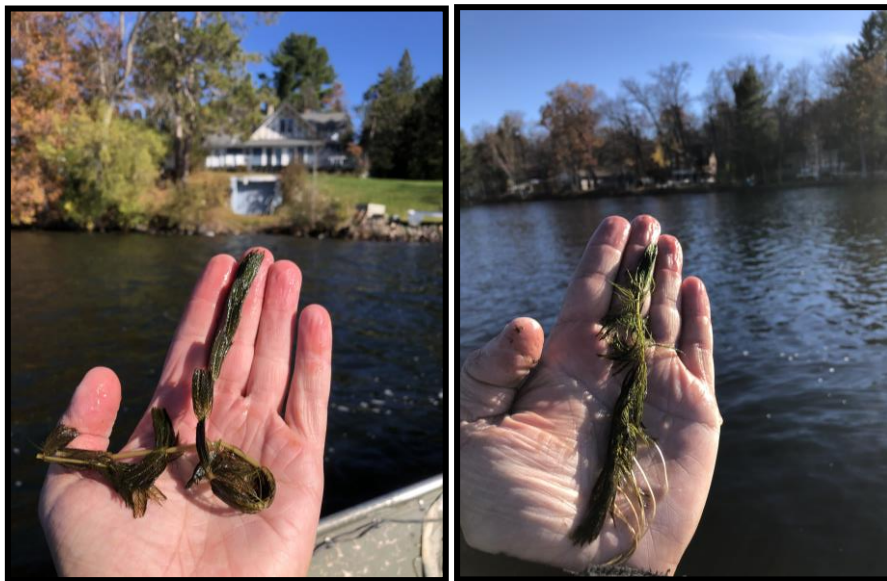
Figure 9: Rooted EWM Sprouts in the Southeast Bay/Floating Fragment along the South Shoreline of the Northwest Bay - 10/30/21

Combing the north bay and northeastern shoreline produced no additional plants. However, we noticed that Northern water-milfoil was abundant suggesting EWM will have ample habitat to expand into in this area. As the littoral zone narrowed on the eastern shoreline, NWM became increasingly less common. Unfortunately, we located a small but already expanding microbed just north of the lake's southeast bay (Figure 8) (Appendix I). These plants were actively fragmenting, and we found scattered satellite plants radiating out on the margins (Figure 9).

Somewhat surprisingly, we didn't find any EWM in the south bays despite there being suitable habitat in many areas. Searching the western shoreline also didn't turn up any new plants, but we did locate two additional single-stemmed plants along the south shoreline of the northwest bay (Figure 9).

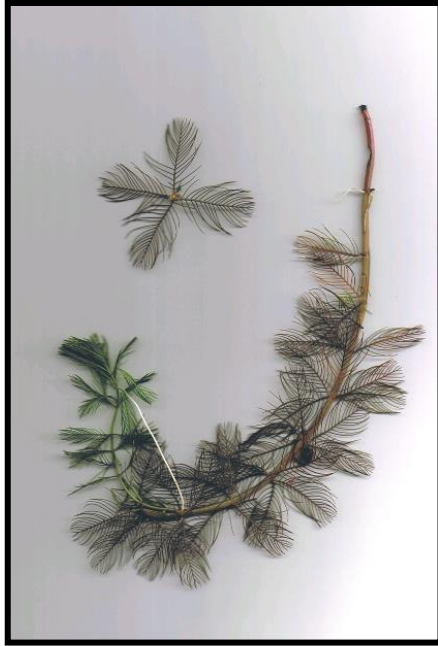
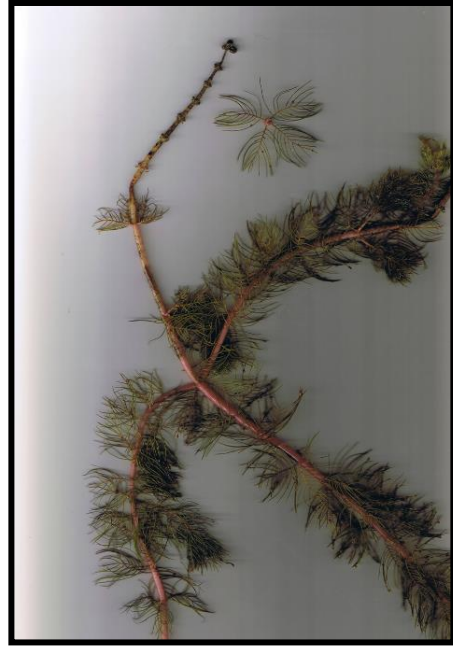
Figure 10: EWM and Northern Water-milfoil Identification (Berg 2007)

Residents should know that Half Moon Lake has a significant amount of the very similar looking Northern water-milfoil – a valuable native plant that provides important fish habitat and is likely to be heavily impacted by any future chemical treatments. NWM is widely distributed throughout the lake's rooted littoral zone, but it does best over sandy and organic muck often just inshore from EWM in 6-10ft of water. Despite its superficial resemblance to EWM, Northern water-milfoil can be told apart by its leaflets numbering <24 that are usually held rigidly at 90 degree angles off the stem when out of water. Conversely, EWM normally has >26 leaflets that fall limp against the stem when out of water (Figure 10). EWM also tends to have a bright red growth tip on the top of the plant whereas NWM has a bright lime green growth tip. NWM on Half Moon Lake is often mixed with other plants, is seldom bed-forming, and rarely canopies on the surface; whereas EWM was often found in nearly monotypic beds that excluded most native species and canopied even in deep water. In the fall, NWM also forms winter buds on the tips of shoots whereas EWM has none. These buds were readily visible during the fall survey (Figure 11).

Eurasian water-milfoil

Northern water-milfoil

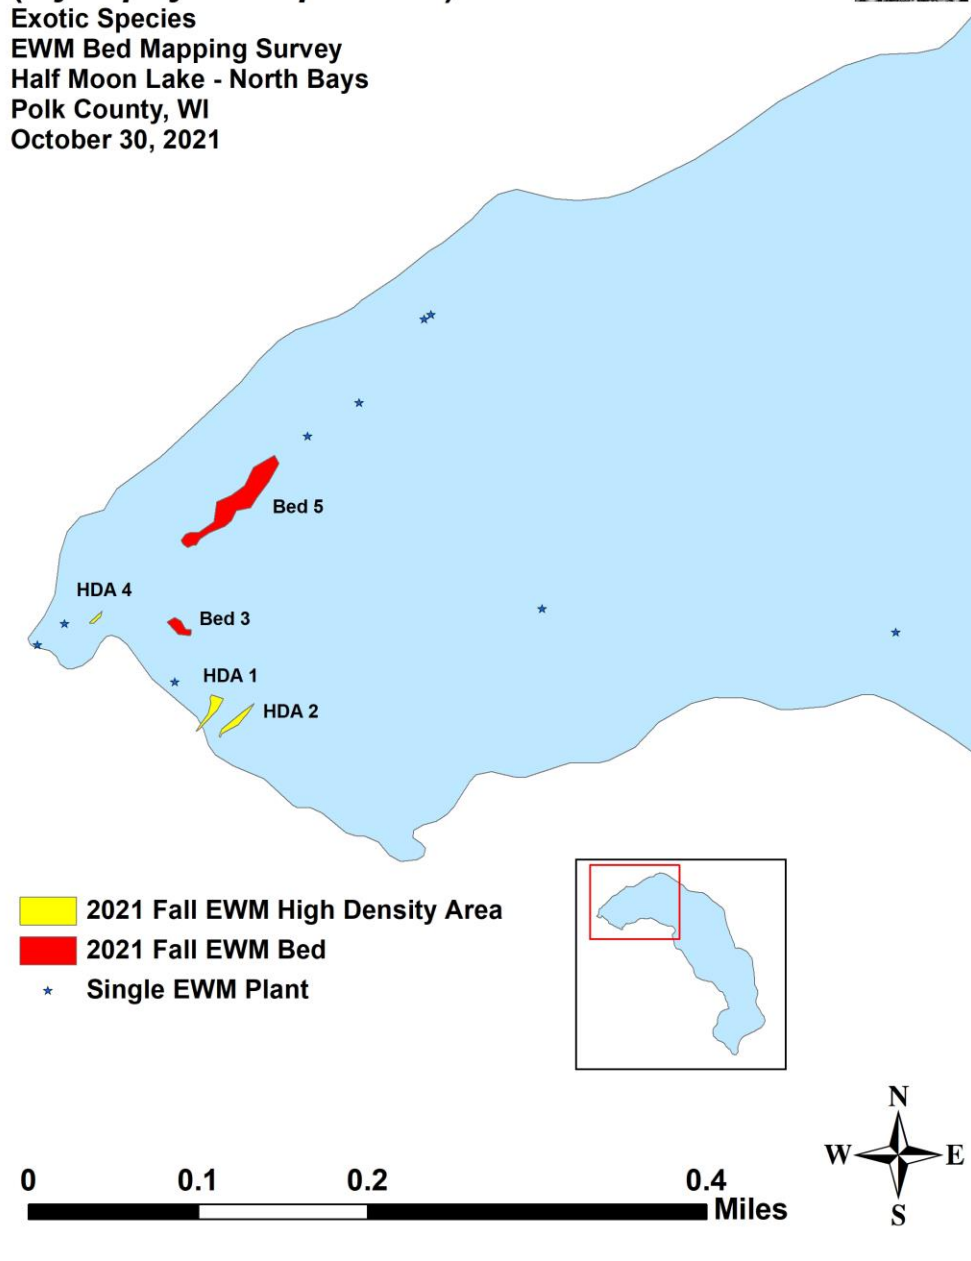
Exotic Species
EWM Bed Mapping Survey
Half Moon Lake - North Bays
Polk County, WI
October 30, 2021
